Situation Photo Log

Saturday, December 29, 2012

Kalamazoo River / Enbridge Spill

Water / Sediment Temperatures

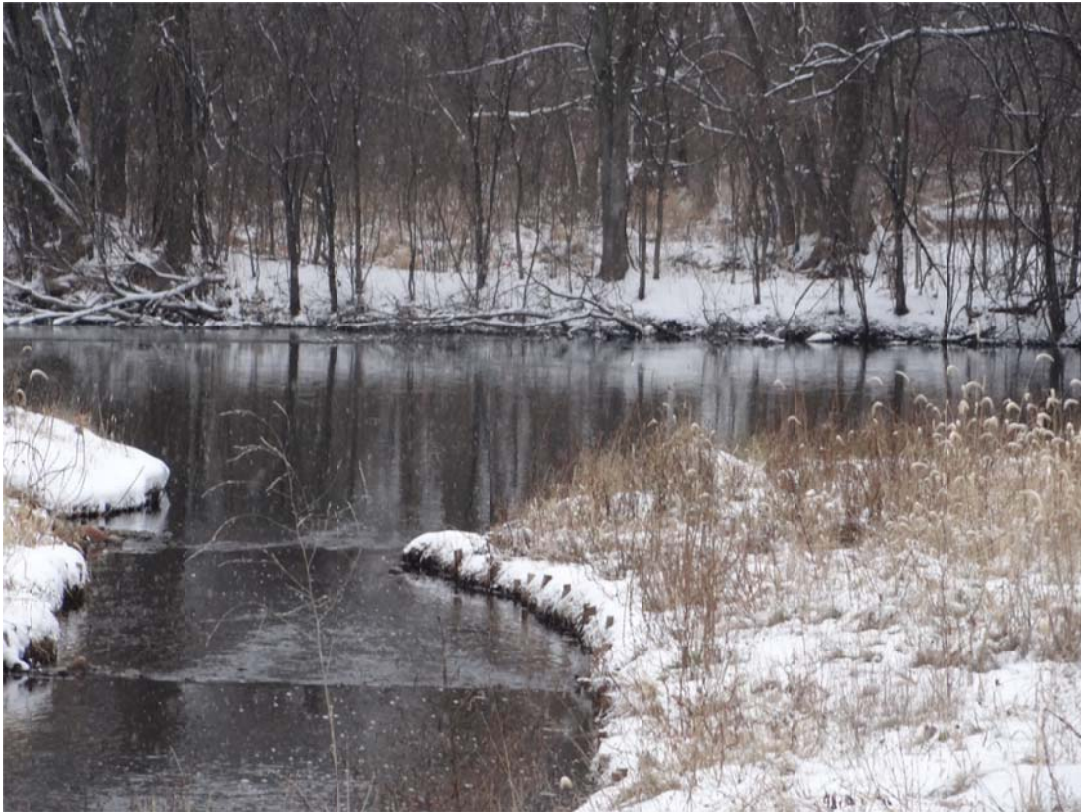
1. Confluence, no sheen or ice observed.

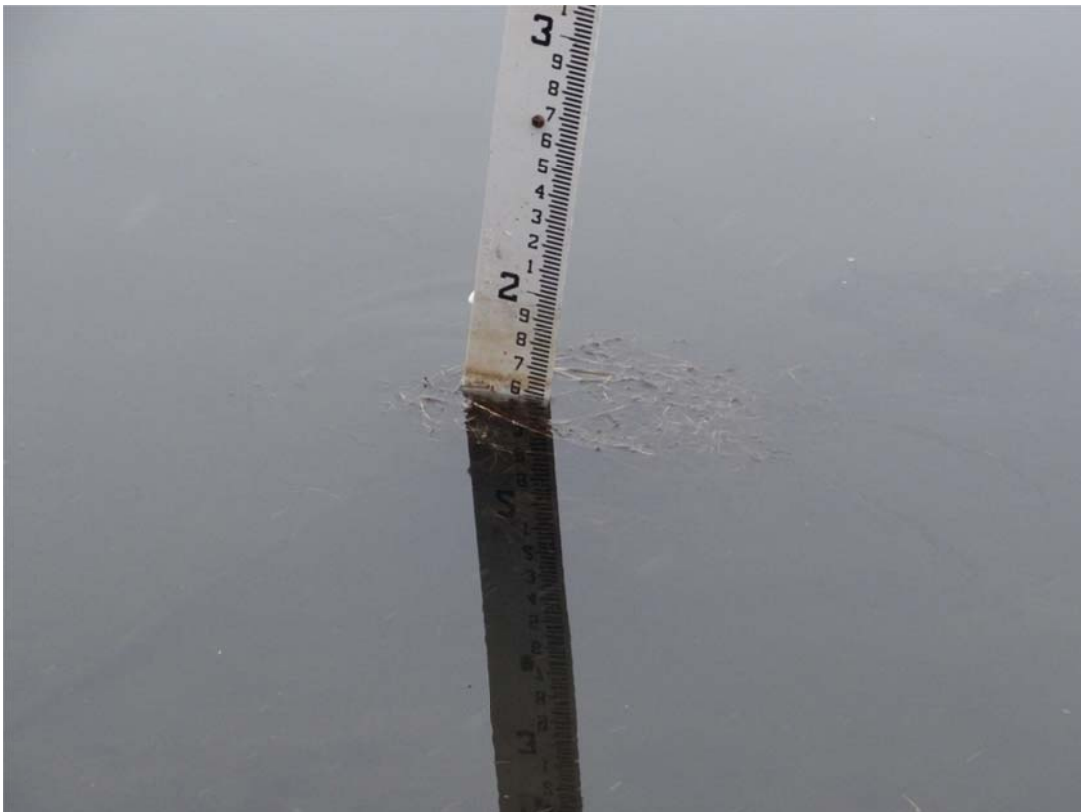
2. Water gauge at C0.4 boat launch. No bank ice observed in vicinity of gauge.

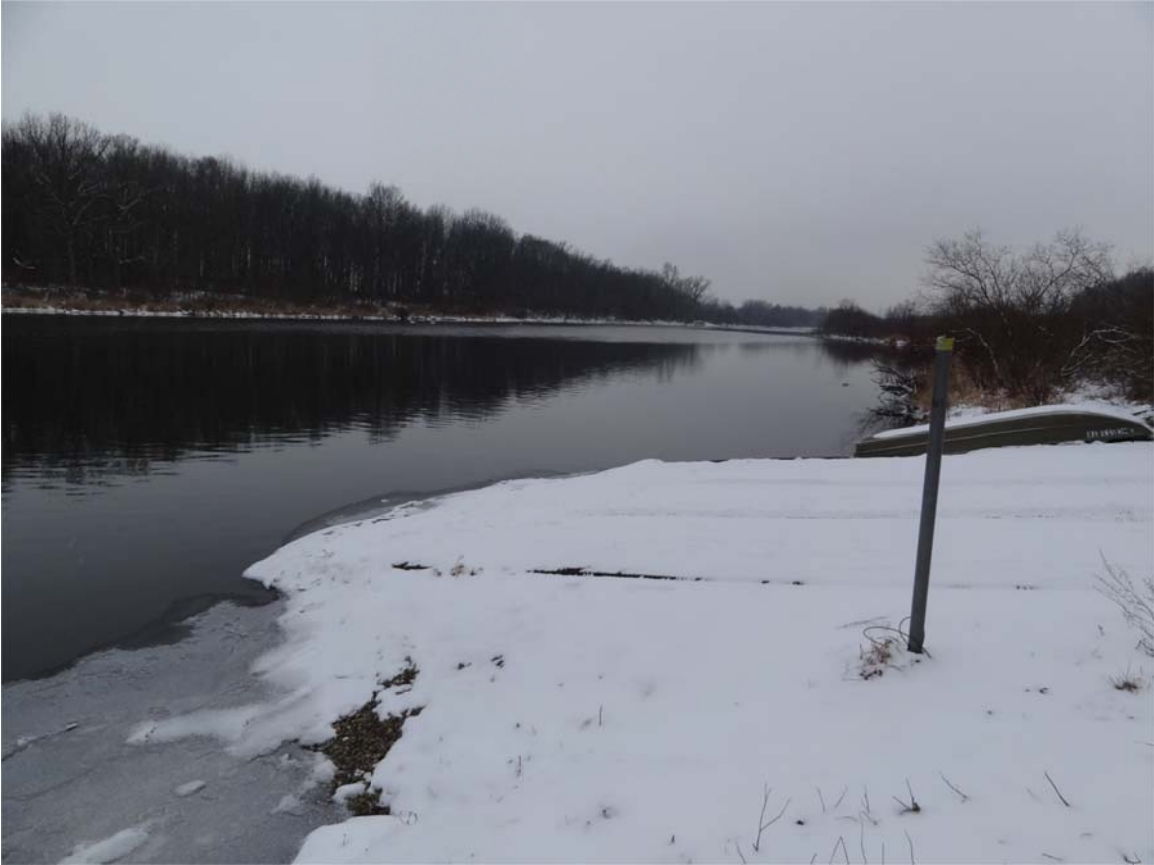
3. C0.4 boat launch. No sheen or significant bank ice observed.

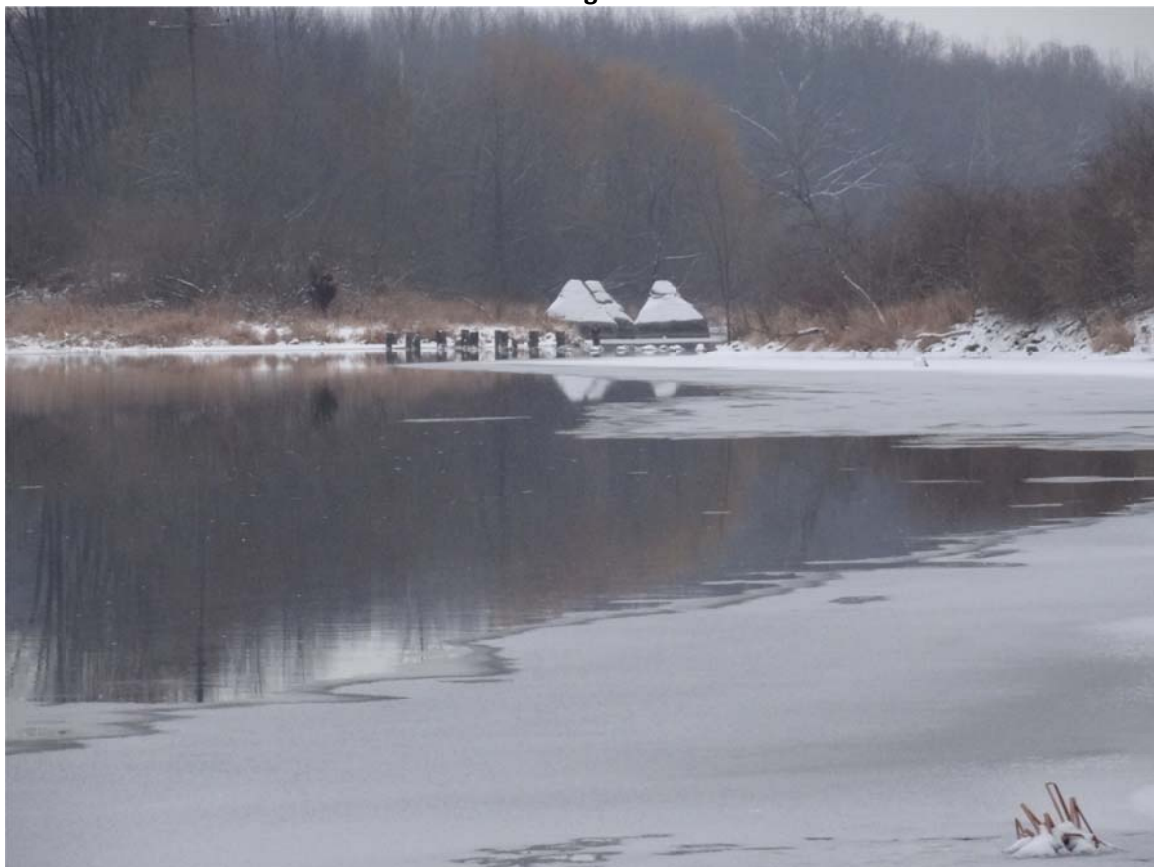
4. MP 5.63 Ceresco Dam trestle, area covered by ice in vicinity of trestle has decreased from yesterday.

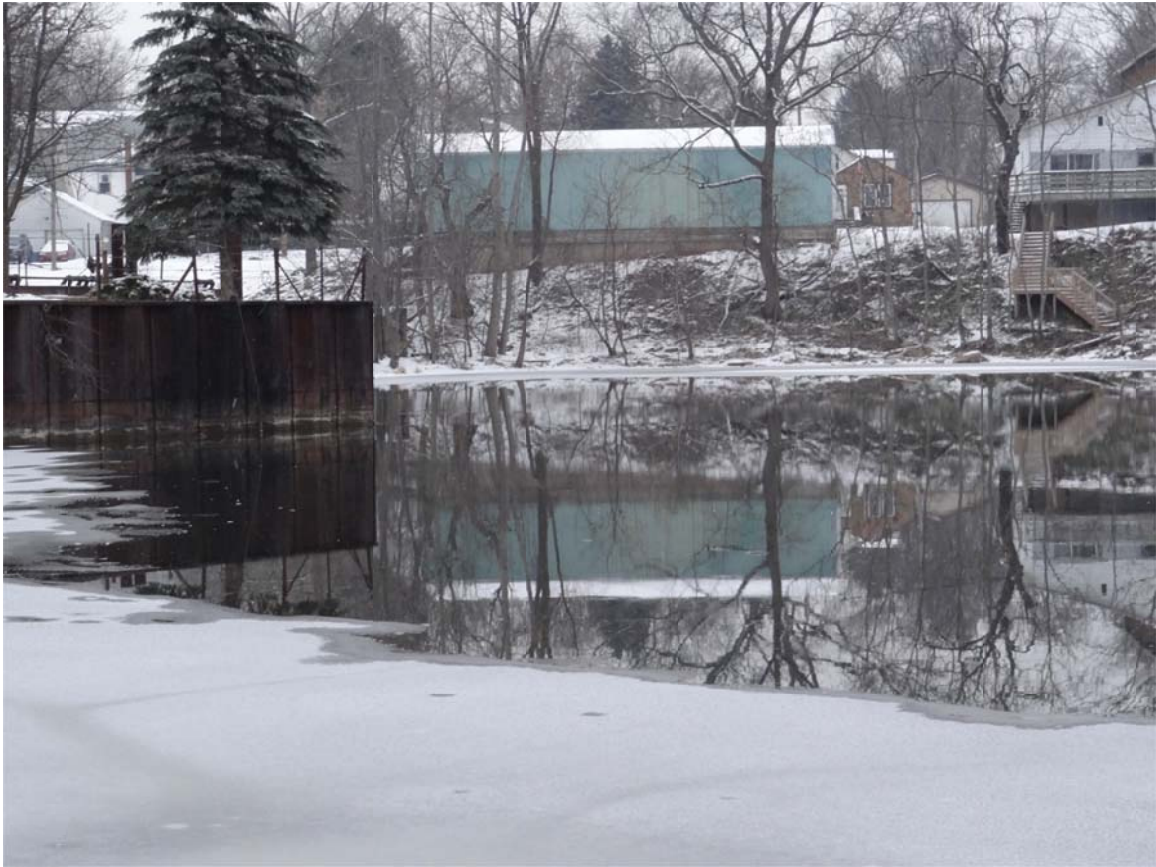
5. Ceresco Dam impoundment, area covered by ice in vicinity of dam has decreased from yesterday.

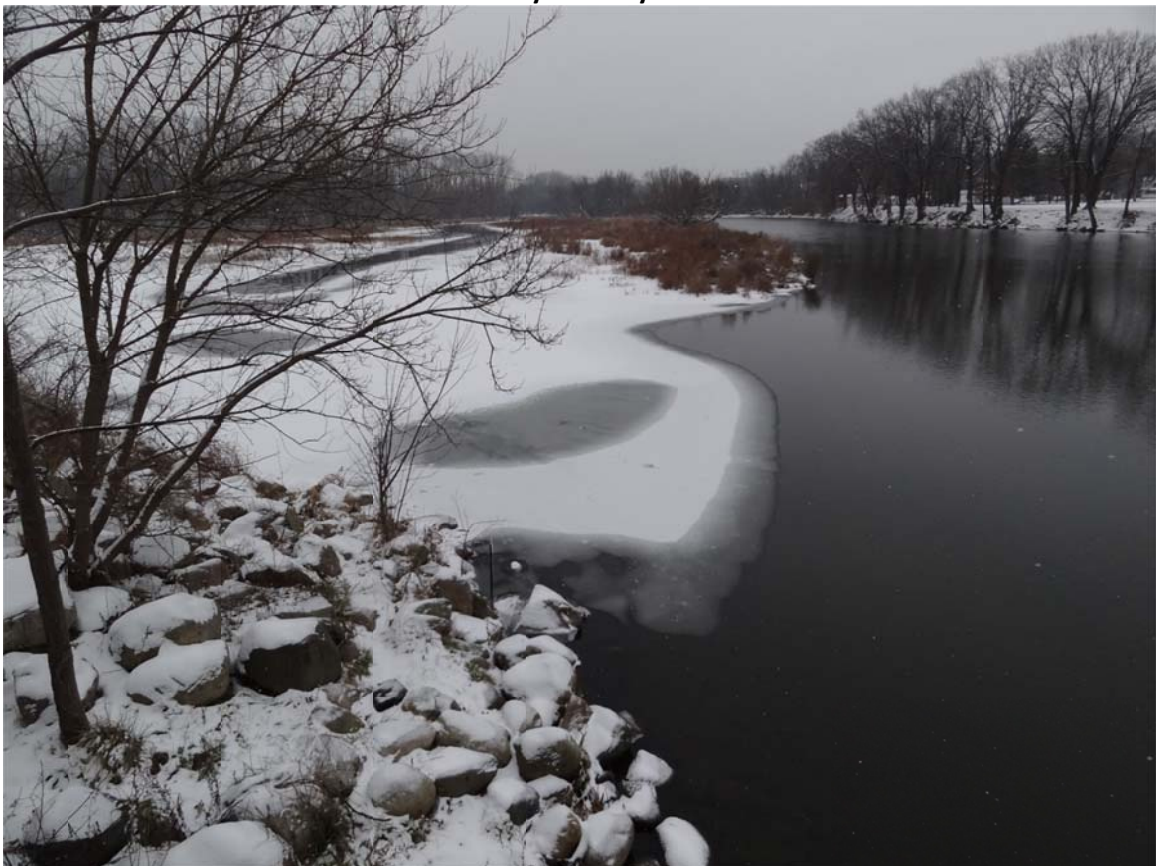
6. MP 15.25 South Mill Pond. No frazil ice observed in river channel.

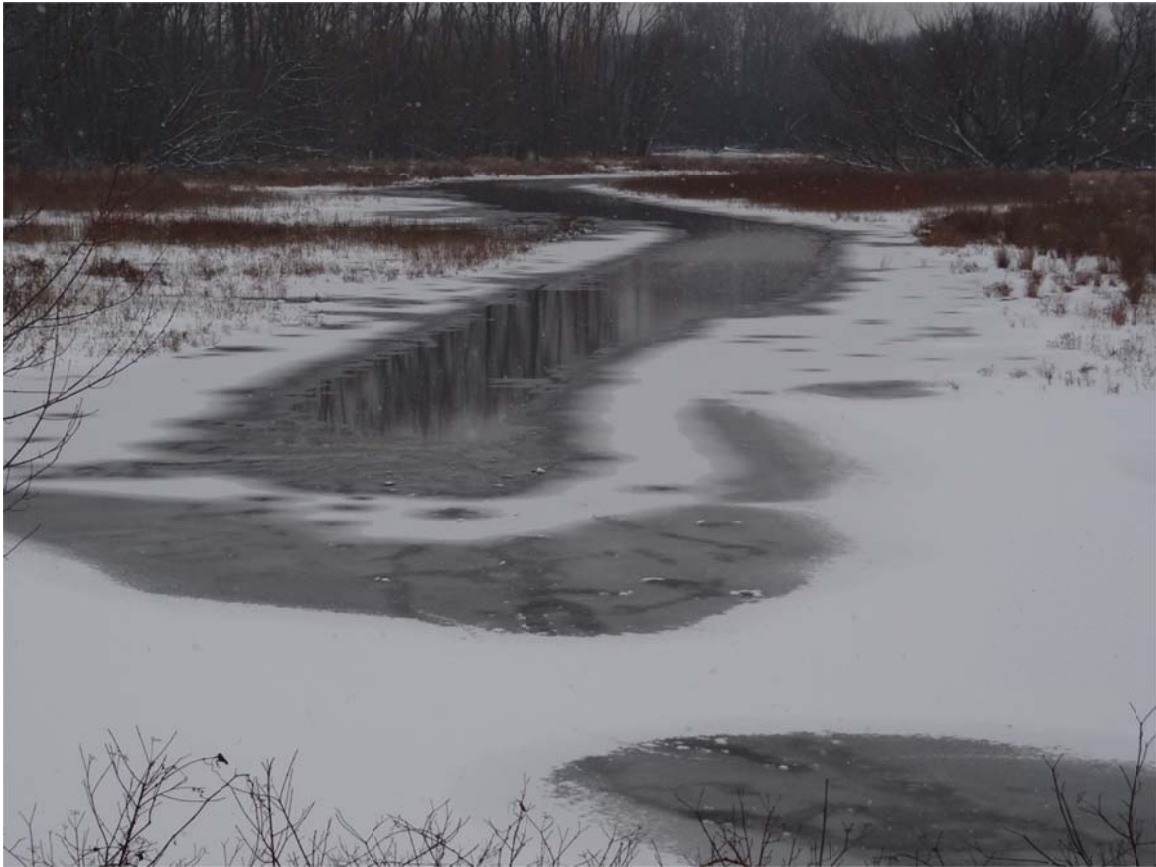
7. MP 15.25 South Mill Pond, ice has receded from yesterday.

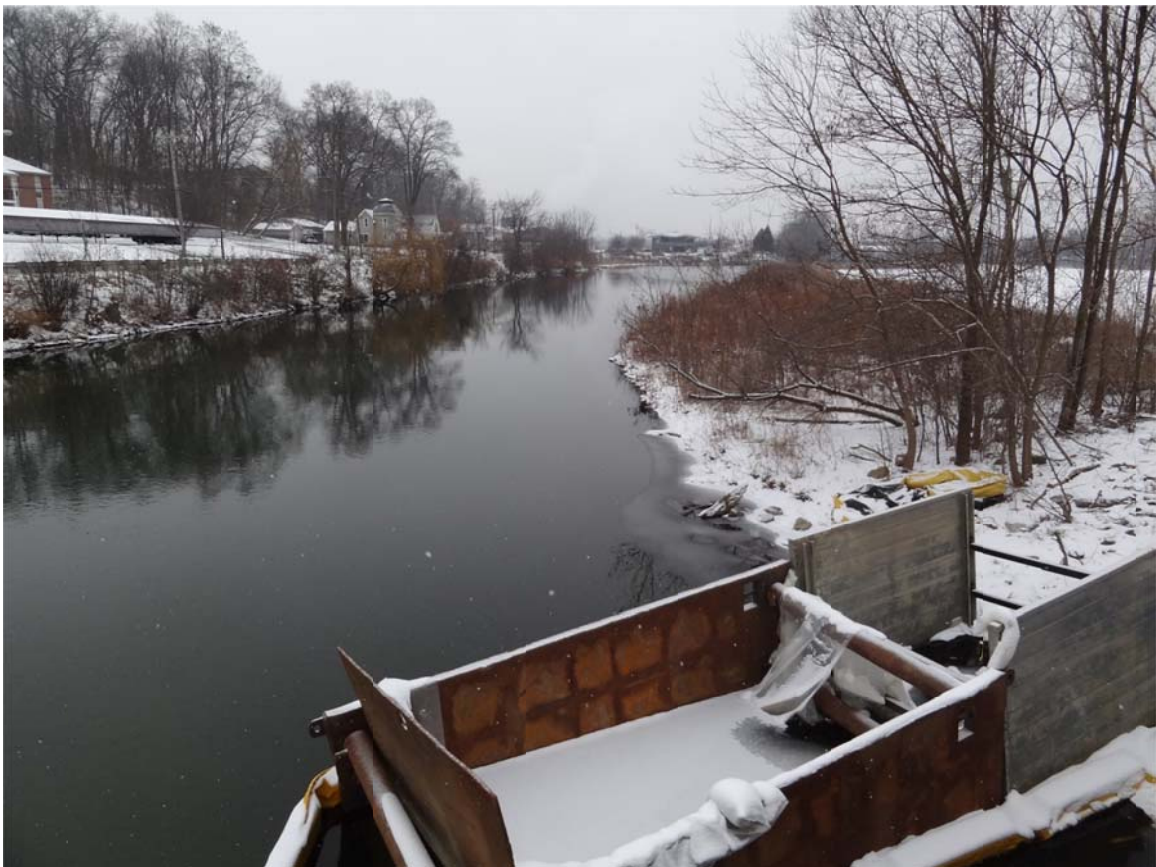
8. MP 15.25 North Mill Pond, no sheen or frazil ice observed.

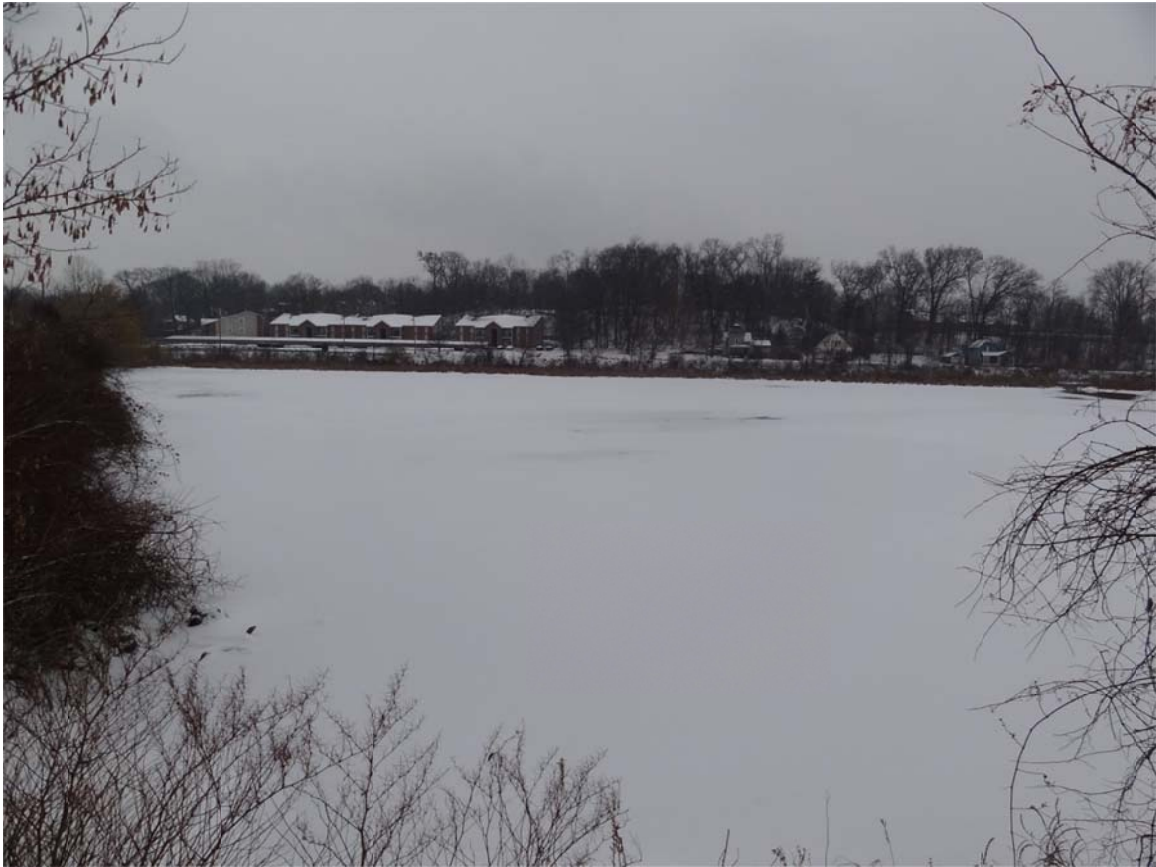
9. MP 15.50 eastern portion of North Mill Pond. Back water area remains covered with ice and snow. No sheen observed.

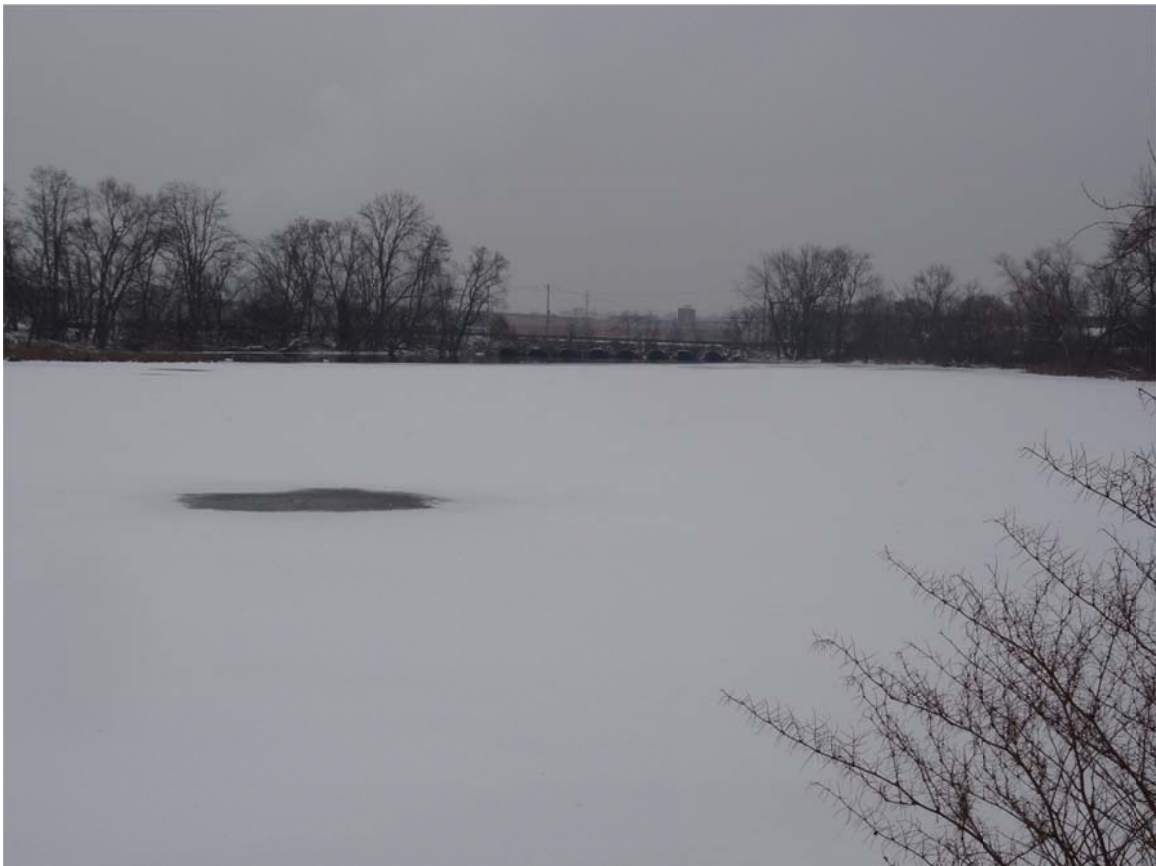
10. MP 15.5 North Mill Pond culverts, no ice observed in vicinity of culverts.

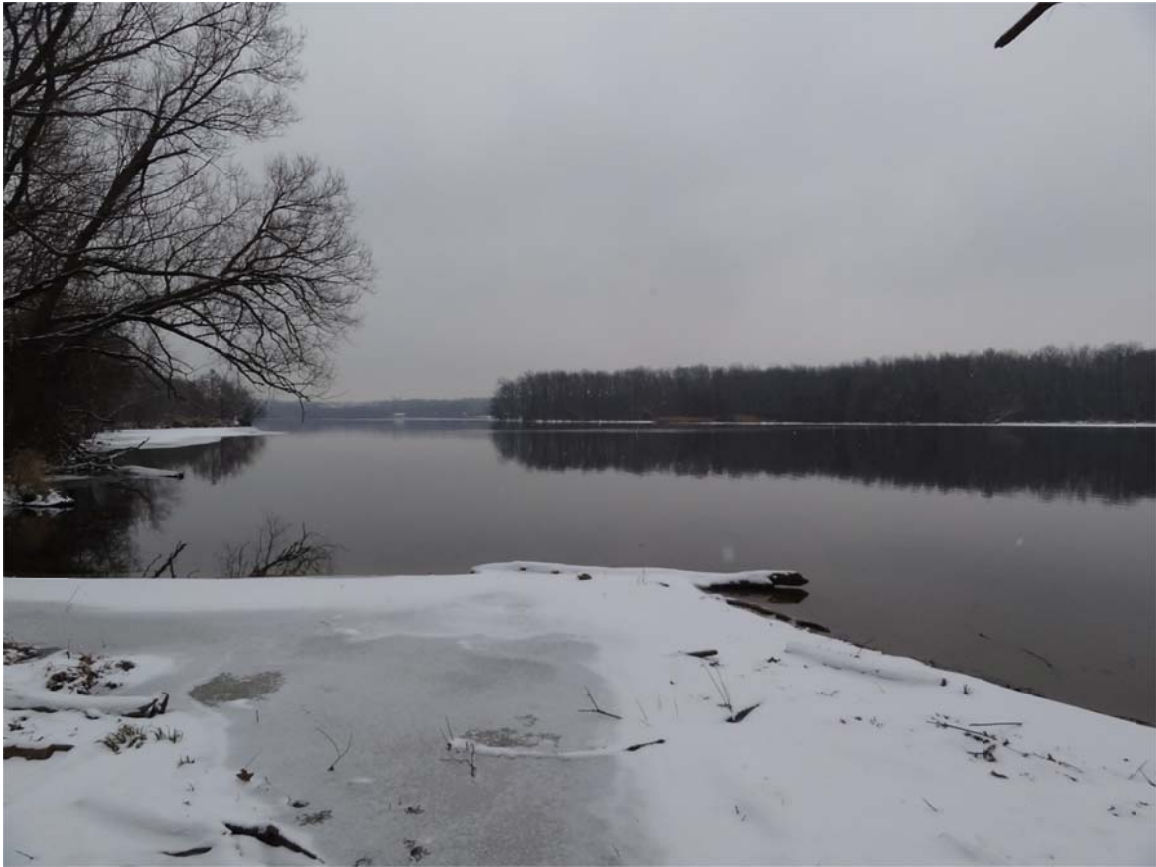
11. Former E4.0 boom location looking east into delta. Minor ice along the bank observed.

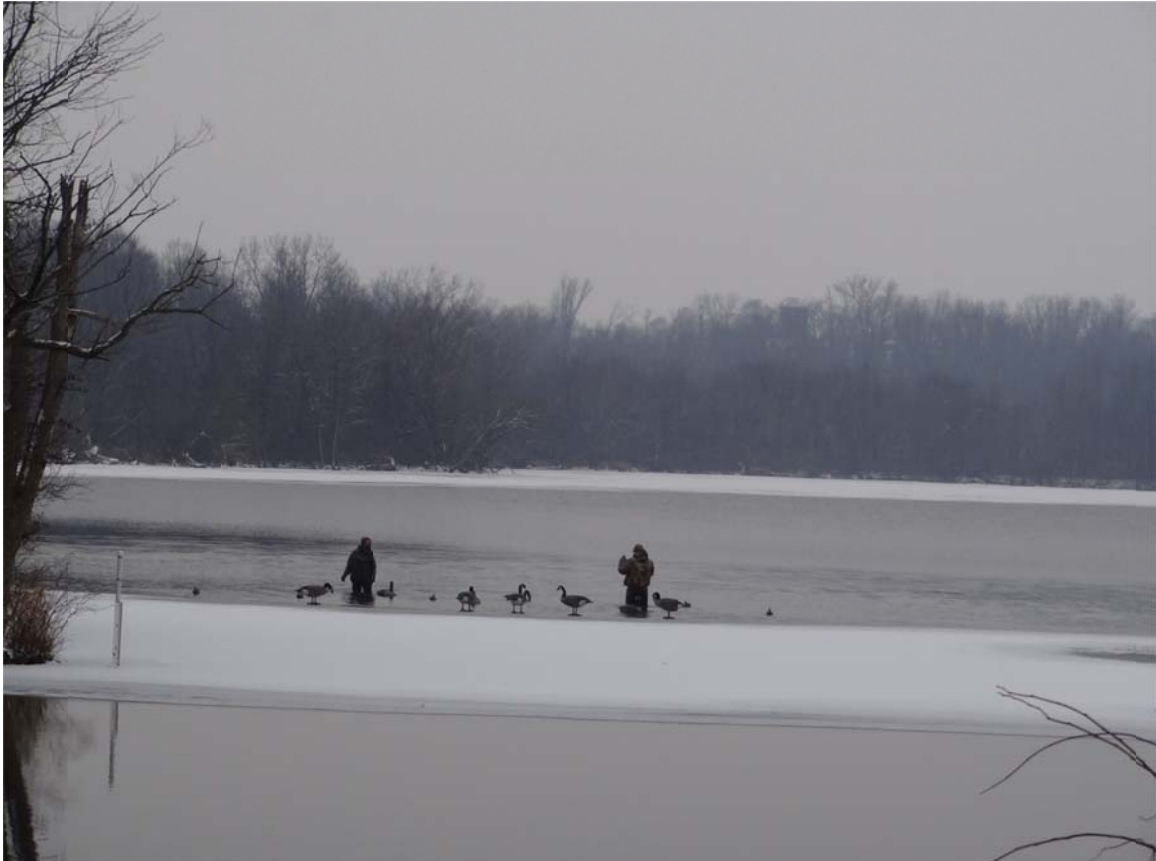
12. E4.0 boat launch. Hunters observed deploying decoys on island just south of E4.0 boat launch.

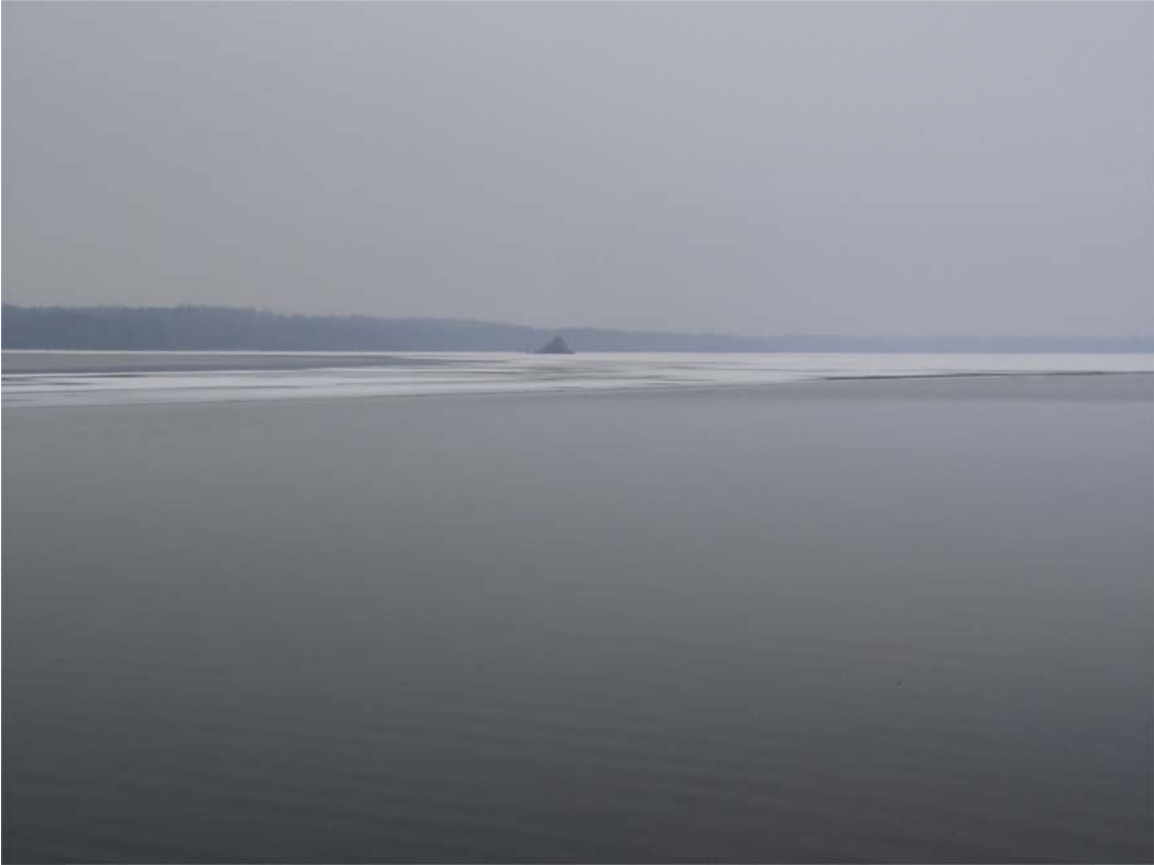
13. View of lake from E4.0 boat launch looking southwest. Ice has receded in southern portion of lake.

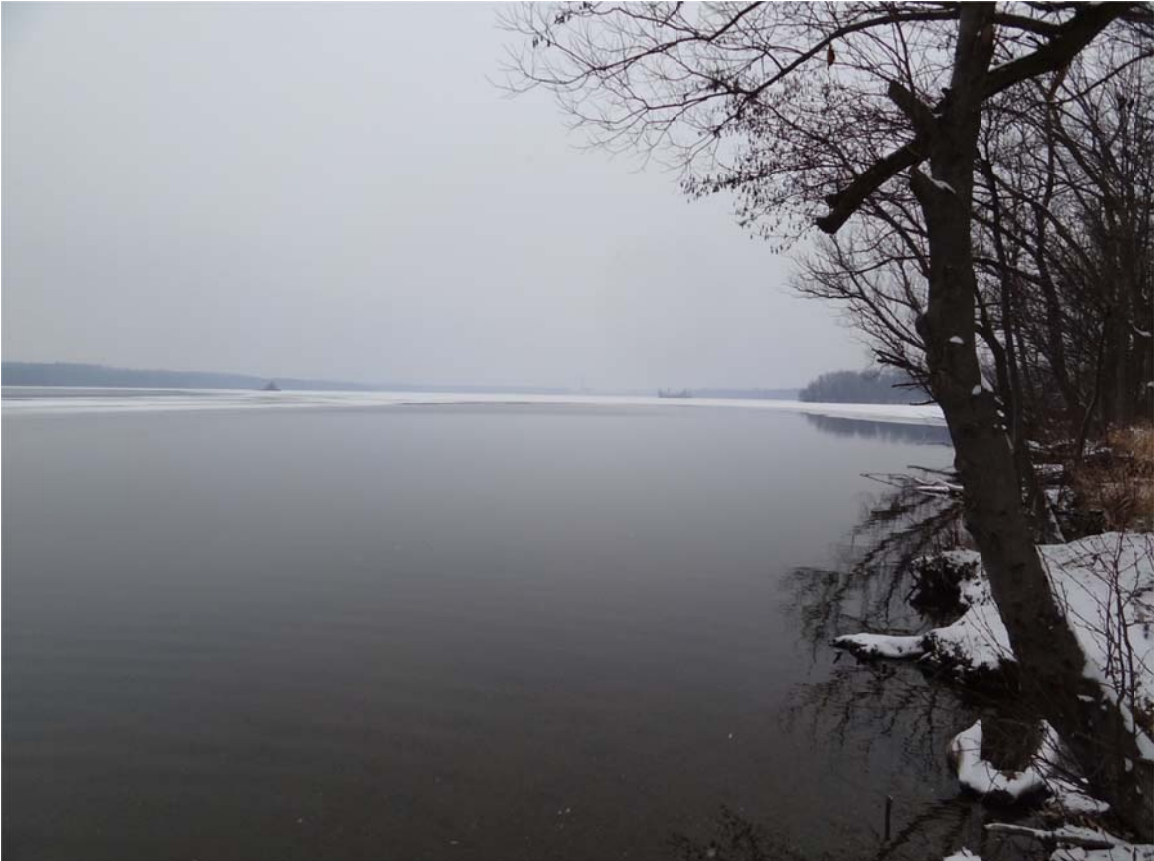
14. View of western end of Morrow. West end of Morrow Lake and north cove appear to be covered in ice.
